Coupe Rear Brakes & Handbrake Cable guide and FAQ - all models

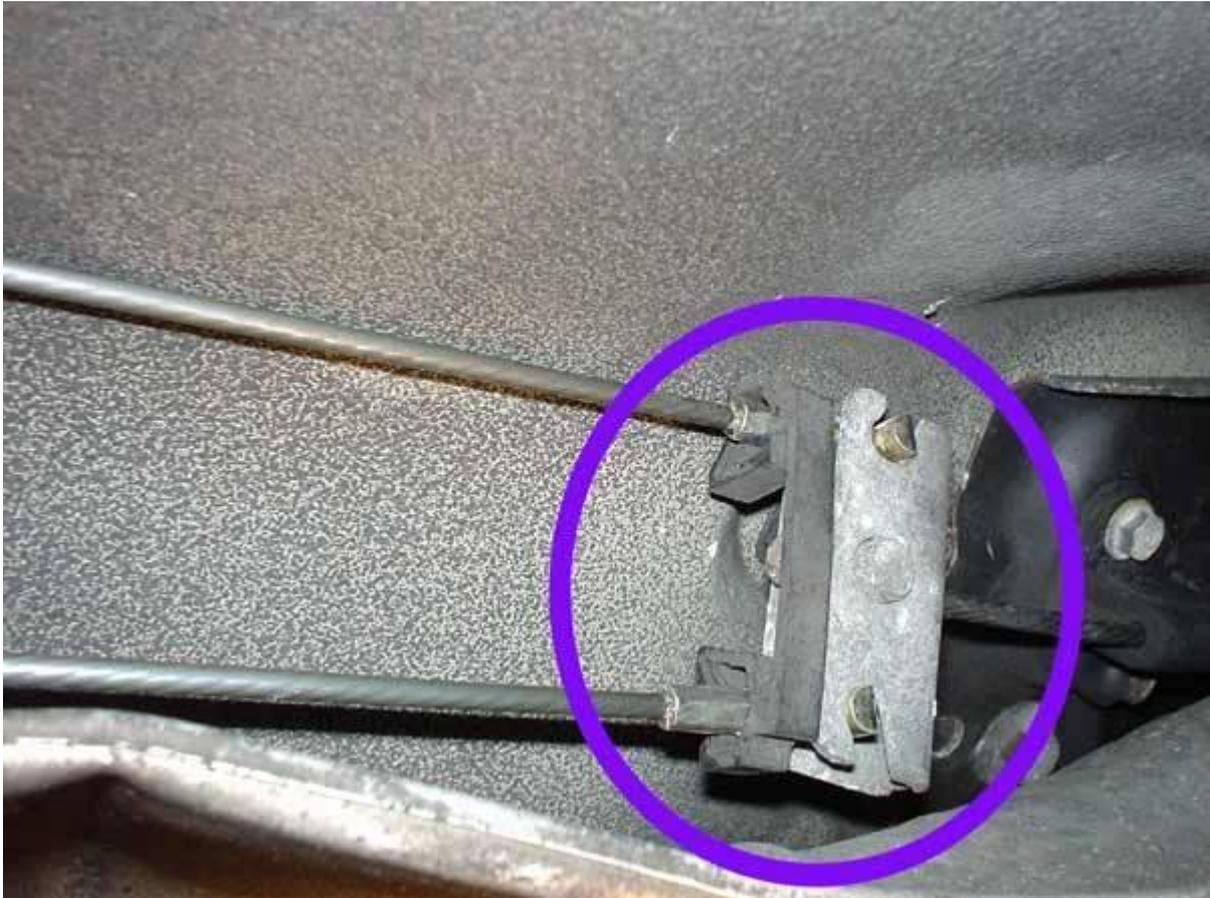
Next, slacken the handbrake tensioner located just below the lever. Turn the nut almost to the end of its thread but don't undo it completely.

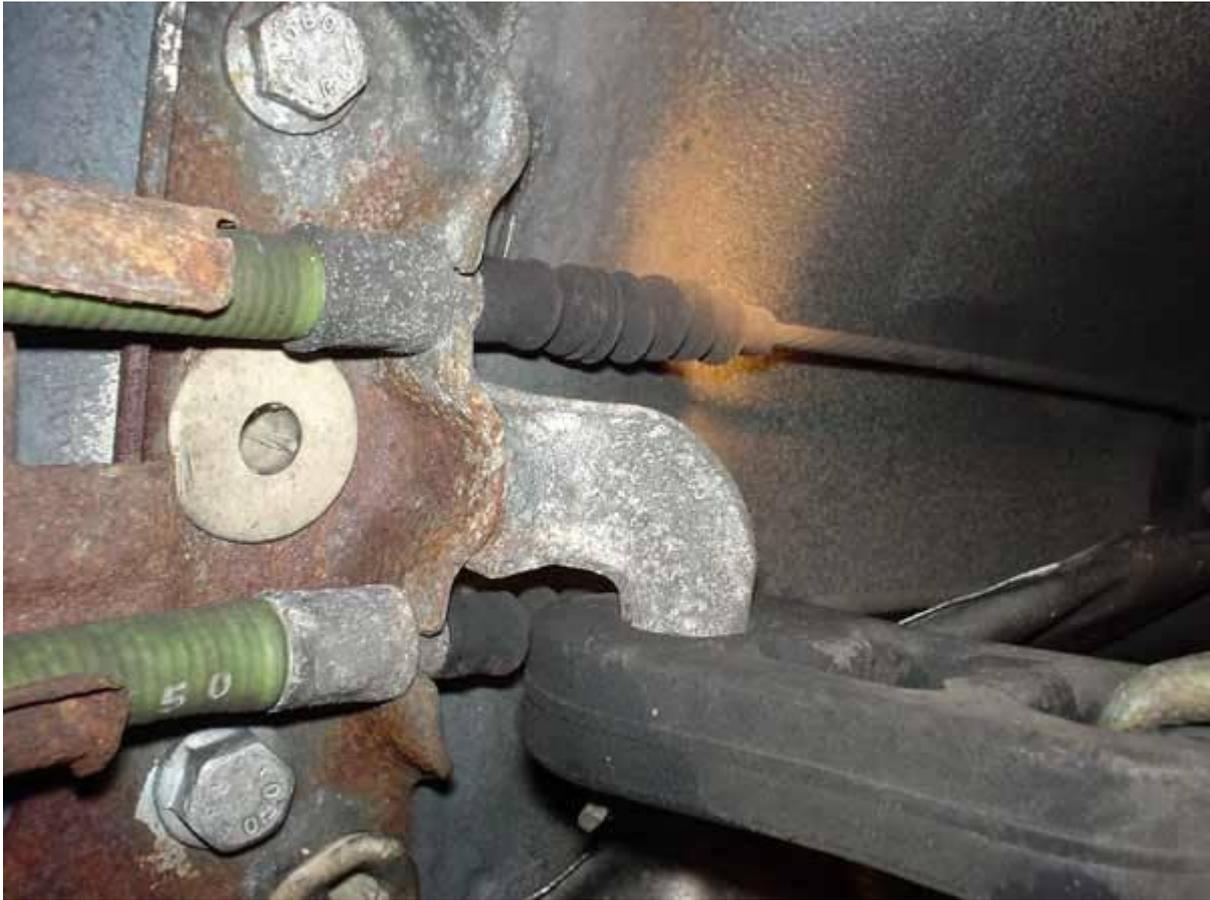
Now release the ends of the cables from the tie bar. This is in the middle of the car underneath and is easily accessible. Just remove the plastic clip and turn the cable ends out of the slots.

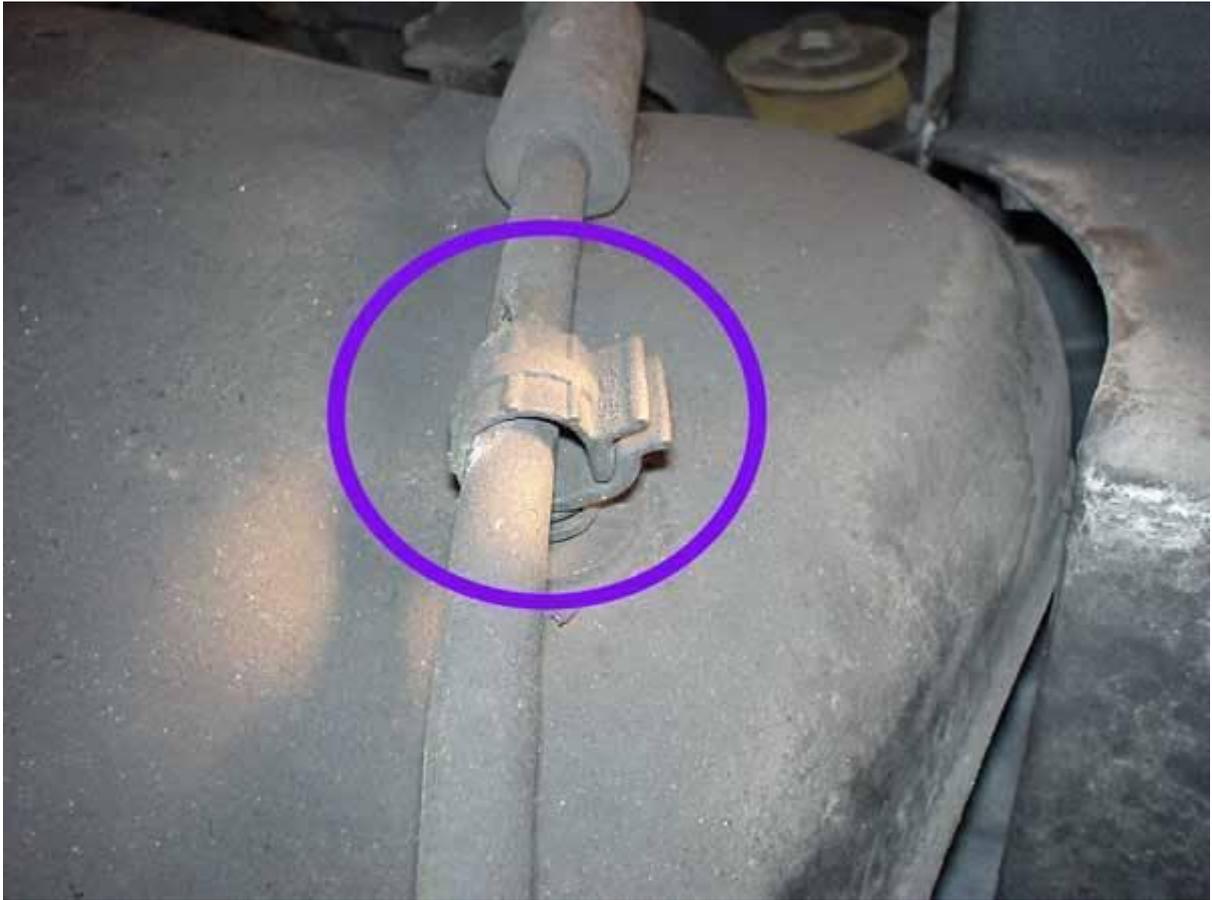
Working towards the rear of the car, simply pull the cable assembly rearwards from these supports.

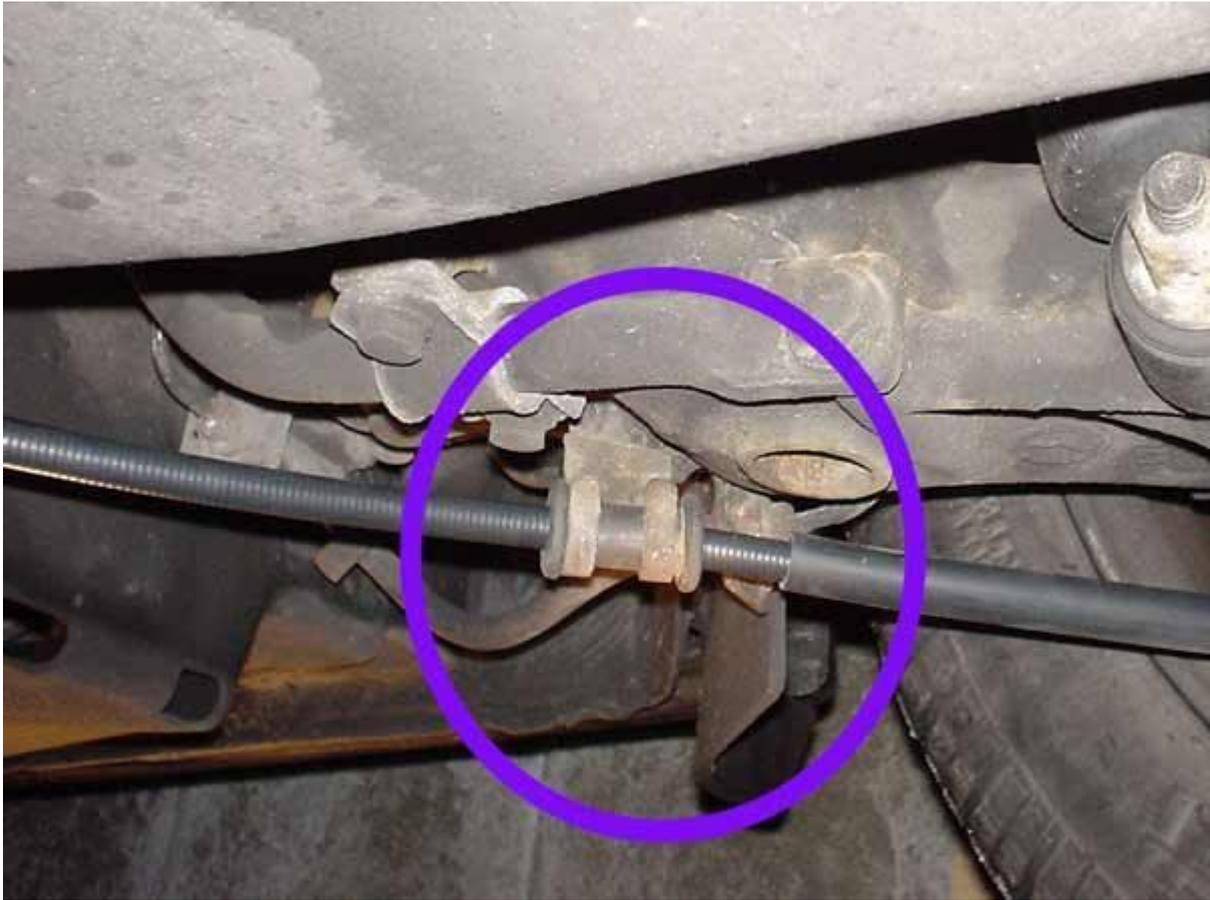
On each side of the car working rearwards you'll come across a clip like this. Simply prise it open with your fingers.

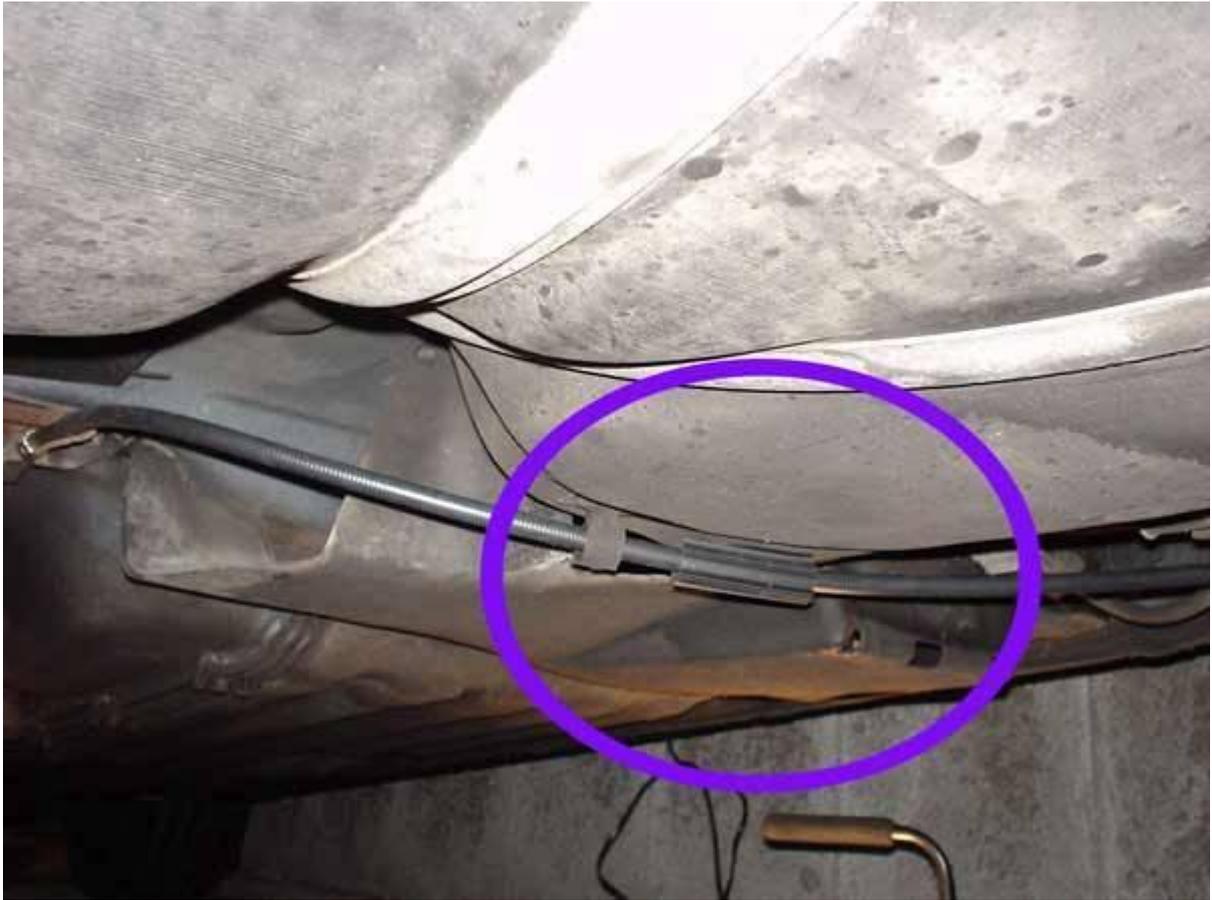
Also on both sides of the car you'll find these supports. The cable sits in them but you'll need to unbolt the 13mm bolt that holds the supports' bracket on to make room to slip the cable out.

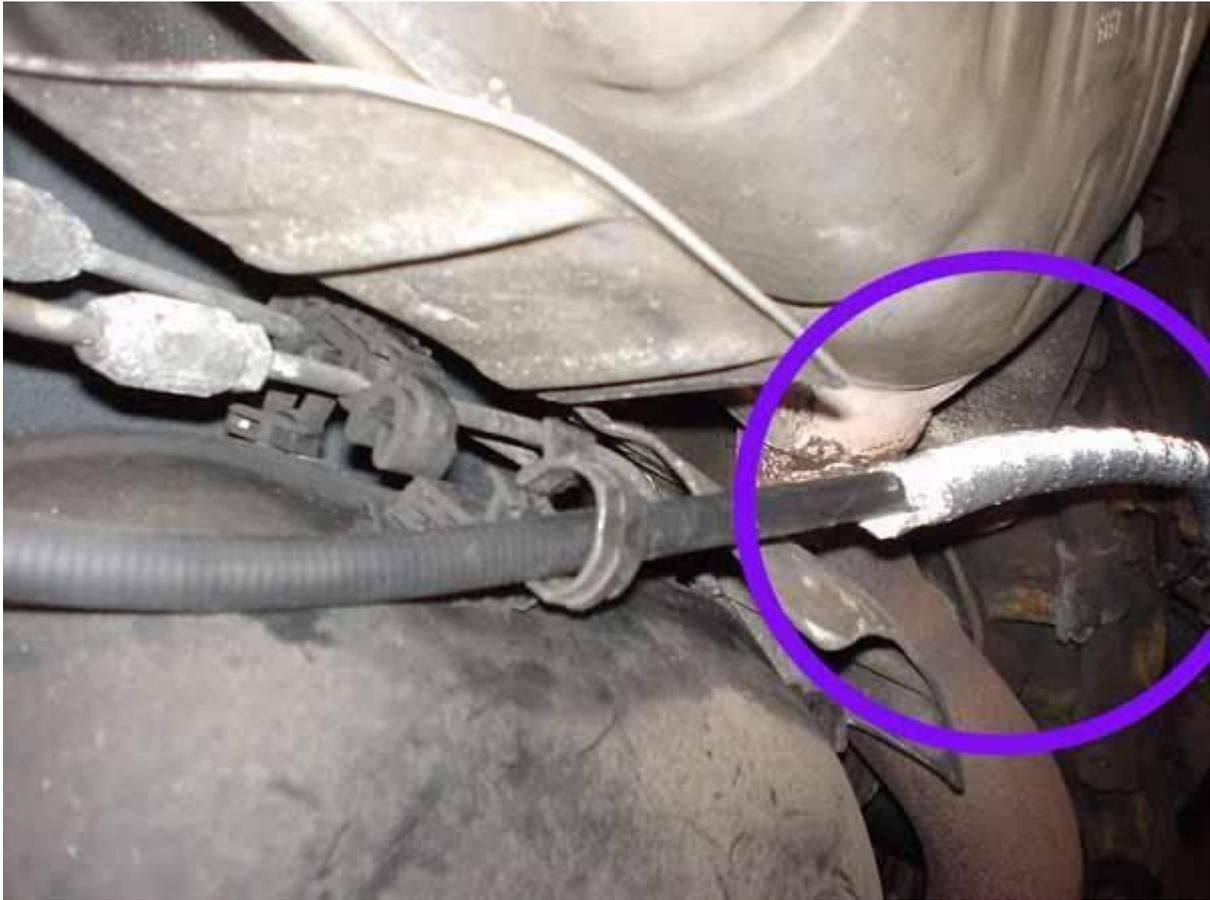
On the side of the car away from the exhaust you'll find this small free moving plastic widget. This stops the cable chafing on the tank.

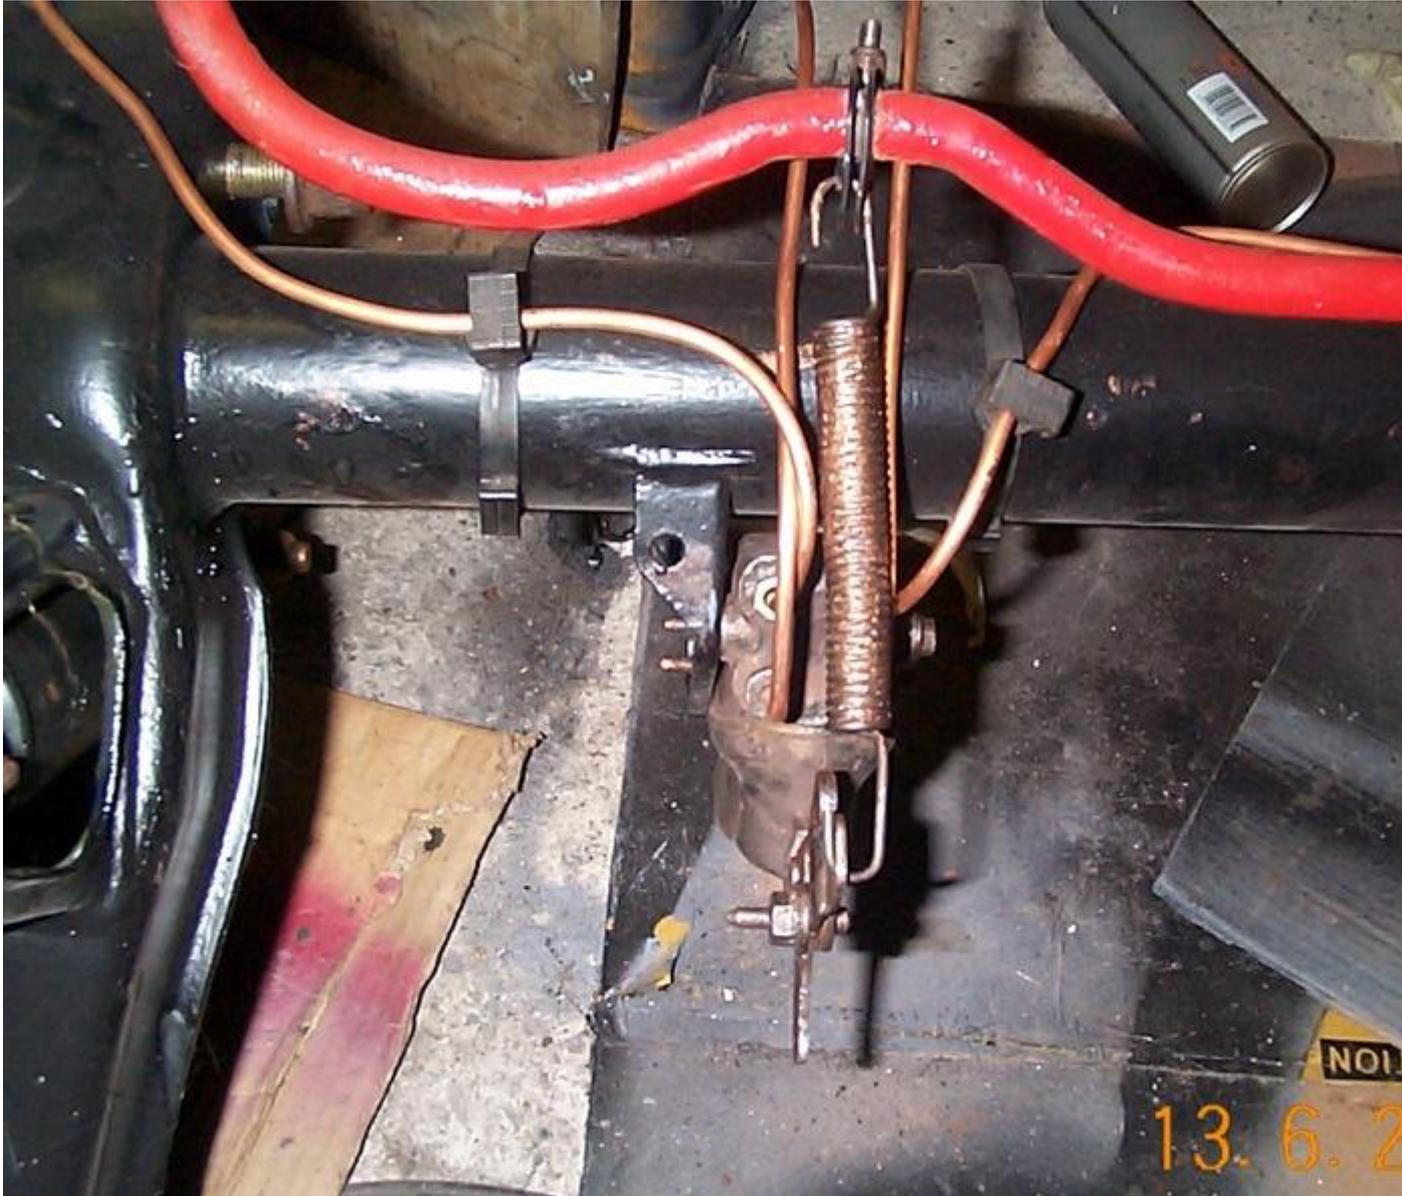
The Brake Compensator valve is attached to the rear sub frame in the middle of the car behind the fuel tank. It is shrouded in a rubber boot but water can get in and cause the mechanism to seize.

Here is a photo of the item (subframe removed from the car, so viewed from above)

The idea is that under hard braking as the nose of the car dips, and the rear rises, the valve reduces pressure to the rear callipers to prevent the brakes from locking. So if the valve has seized in this position foot brake efficiency at the MOT will be poor. It is worth checking the condition of the rubber boot occasionally and giving the area behind the boot a good spray of copper grease every year or so..

- Support the rear on axle stands underneath each shock (or have the car on ramps). Take the spring and rubber boot off the compensator and remove the centre shaft and washer.
Wire brush the lever to clean it up a bit and free the adjustment bolt. With the help of pliers, WD40 and a rag, clean up the centre shaft and two valve pistons
